INTERIM REPORT

AUGUST 1976

APPLICATION OF CERAMIC NOZZLES
TO 10KW ENGINE

SOLAR DIVISION OF INTERNATIONAL HARVESTER COMPANY

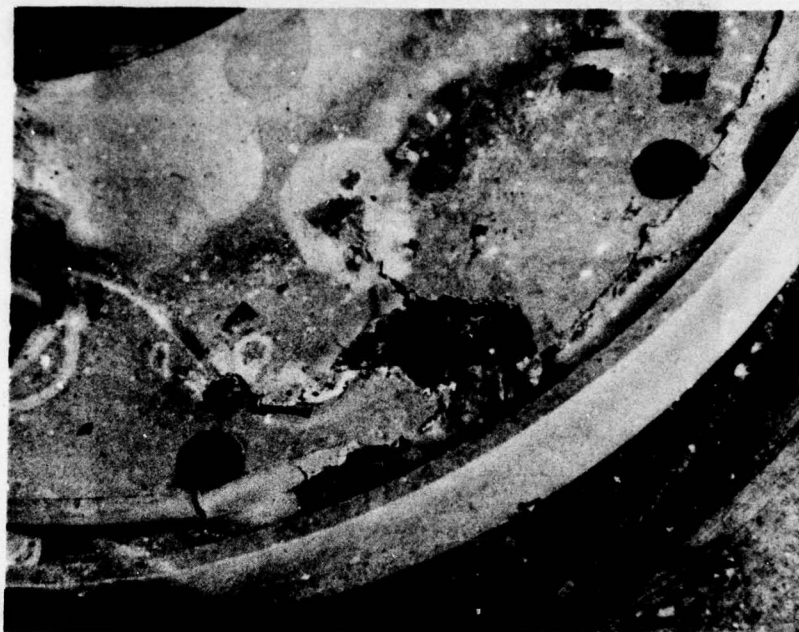
FIGURE 78. MELTED SECTION OF REAR SHROUD IN THE VICINITY OF VANE LOCATION #13. (Photo Taken After Completion of Dust Erosion and Corrosion Tests.)

During the first hour of test, a section of the nozzle rear shroud adjacent to vane #13 melted (see Fig. 78). This was the result of an error in control temperature and a high pattern factor caused by the dust impinger which aspirates combustion gasses preferentially from nozzle passages surrounding vane location #13. A 1122°C (2050°F) to 1149°C (2100°F)

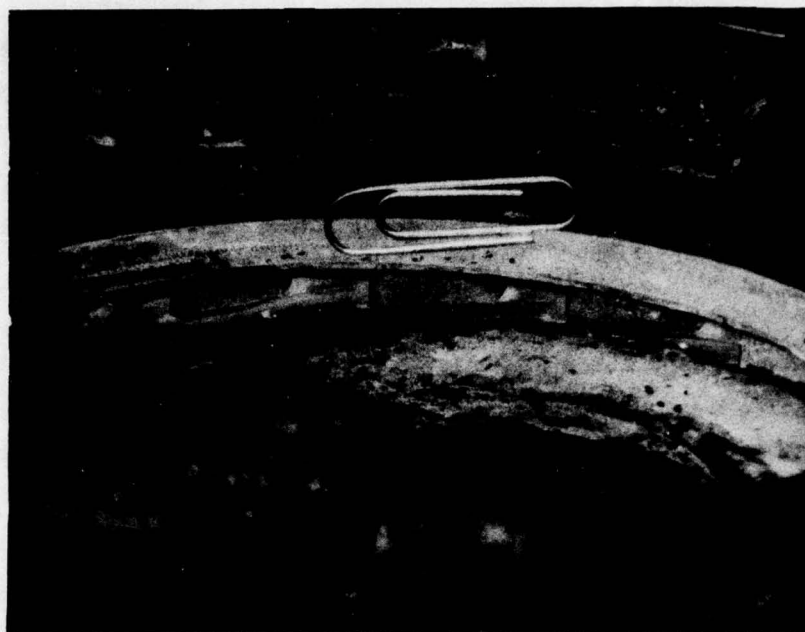
FIGURE 81a. DOWNSTREAM SIDE OF NOZZLE AFTER RIG CORROSION TEST
(Vaness Shown are from Left to Right #9, 8, 7, 6 & 5)

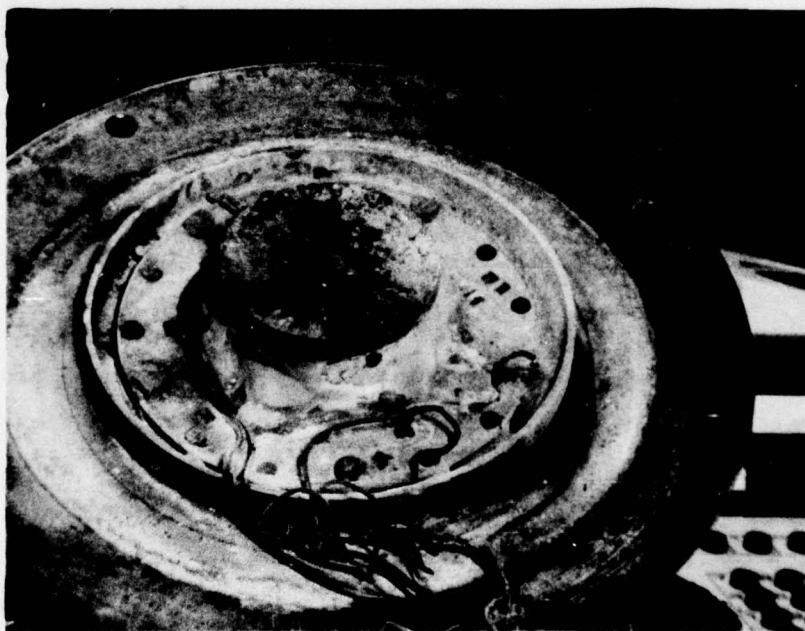
FIGURE 81b. UPSTREAM SIDE ON NOZZLE AFTER RIG CORROSION TEST

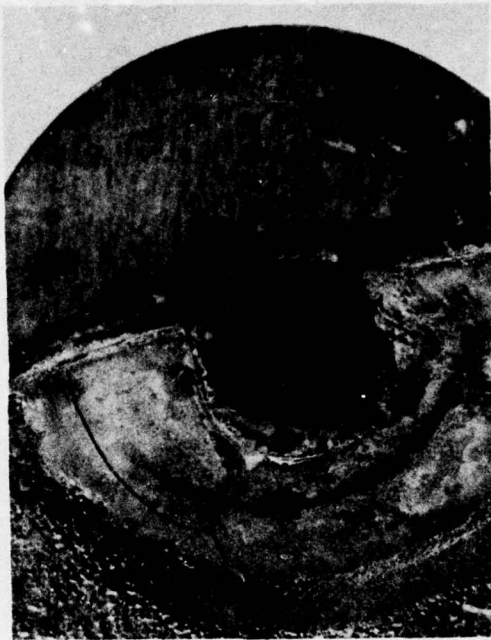
FIGURE 88. THERMAL CRACK IN BOTTOM CERAMIC SHROUD AT HOLDING PIN "B"

A crack developed at locating pin 'B' during test and propagated towards the center of the upstream shroud. It is shown in Figures 87 and 88. Other cracks occurred at locating pin 'A' (see Fig. 89) but did not propagate beyond the pin region. It appears that the cracks resulted from localized thermal stresses since the pins run relatively cool because of direct mounting to the water cooled stainless steel plate. The refrasil insulation wafers between the holding pin head and lower shroud were found to be impregnated with molten products at locations 'A' and 'B'. The insulating wafer at location 'C' was relatively free of molten materials. Since location 'C' on the lower shroud showed no cracking it seems probable that the short circuiting of the thermal insulation at location 'A' and 'B' was
